# Analysis of two nonfatal lightning accidents in Colombia

Several lightning accidents involving human fatalities and injuries are reported every year in Colombia. This work presents and discusses two non-fatal lightning accidents, where the victims survived without evident permanent disabling traumas. In both cases, it was observed that metallic objects such as necklaces or buckle belts worn by the victims were intercepted by the lightning current. These metallic objects could possibly be a pathway to keep the lightning current on the victim's skin surface. To understand the interaction of these metallic objects and the indirect lightning currents, both the visual consequences of the indirect lightning current on the victim's skin and a comprehensive description of the cases scenarios are presented.

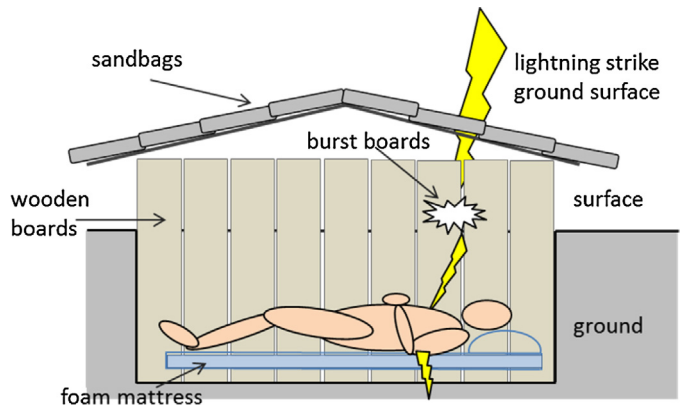
**Fig. 2.** Schematic representation of Case A, in which a soldier was resting inside of a semi-underground military shelter, which was struck by lightning.

Lightning struck directly on the ground surface circa 1 m from the shelter roof and the lightning current, instead of being dissipated on the surrounding ground, part of it flowed across the trench walls arrangement, breaking them and reaching the soldier's right side. The indirect lightning current left three diverted recognizable burn paths on the sergeant's skin, as shown in the photographs in Fig. 4. From these images, the indirect lightning current paths in the victim's body could be reconstructed. The lightning probably hits initially close to his right shoulder. Thereafter the current crossed superficially his right shoulder and was routed to the portable communication radio placed over the sergeant's torso and through the necklace he wore, ending at the elbow's area of his left arm. Fig. 4(a)–(f) shows the burns left by the lightning current on the soldier's body, on the necklace and on the sergeant's portable communication unit.

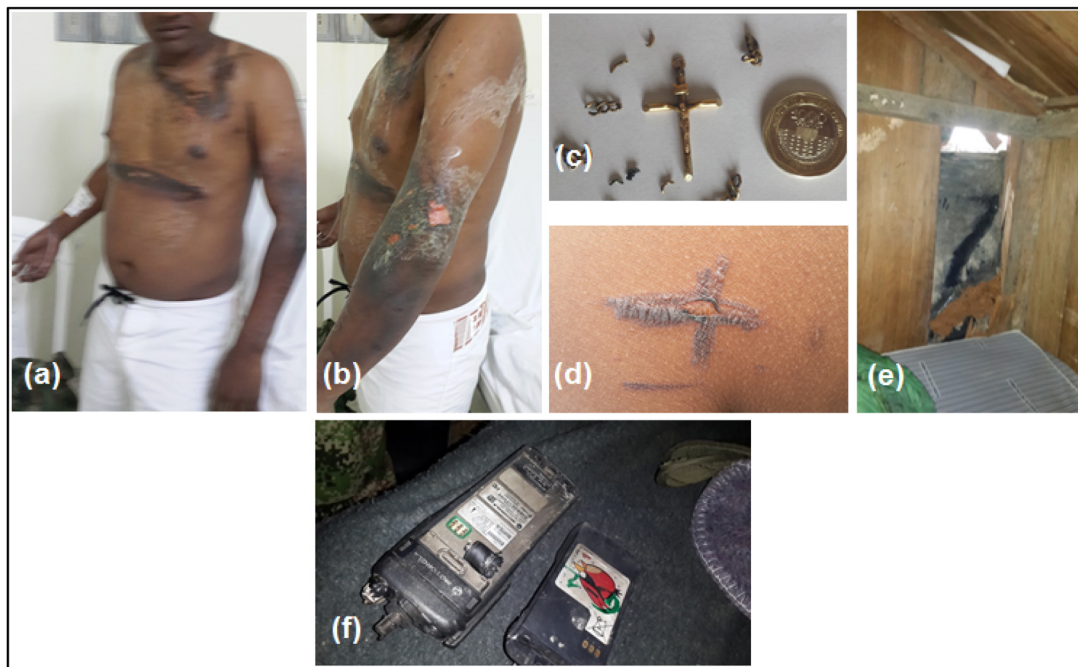
The necklace conducted a branch of the lightning current overheating it, burning around the soldier's neck, while it was melted and broken in small pieces, as it can be seen in Fig. 4(c). The overheated necklace left partial-thickness and full-thickness burns

**Fig. 4.** Consequences of the lightning event in Case A: the current left superficial linear burn marks of the paths in the man's chest and neck (a), a full thickness burn in their left elbow (b), their metallic necklace burst in pieces (c), a burned cross tattoo in his skin (d) due to overheated cross pendant, the shelter condition after the lightning impact with burst wooden boards (e) and the burned soldier's communication radio (f).

around the victim's neck, leaving also a cross tattoo (of the cross pendant necklace) shown in Fig. 4(d) [14–16]. Finally, the current left the victim's body on his left hand side by the elbow, as it can be seen in Fig. 4(b).

The portable communication radio unit conducted also part of the lightning current, overheating it and leaving superficial linear burns on the soldier's chest [15] as well in the elbow region of his left arm leaving deep partial-thickness burns in the elbow proximal

In Case A, as it can be seen in the reported photographs, lightning currents cause linear burns due to the flash vaporization of water, of the moisture and sweat, into steam in an evaporation flashover process [13]. Also, the current effect left thermal burns by con-

tact, between the skin and the overheated necklace and pendant, producing superficial and deep thickness burns.

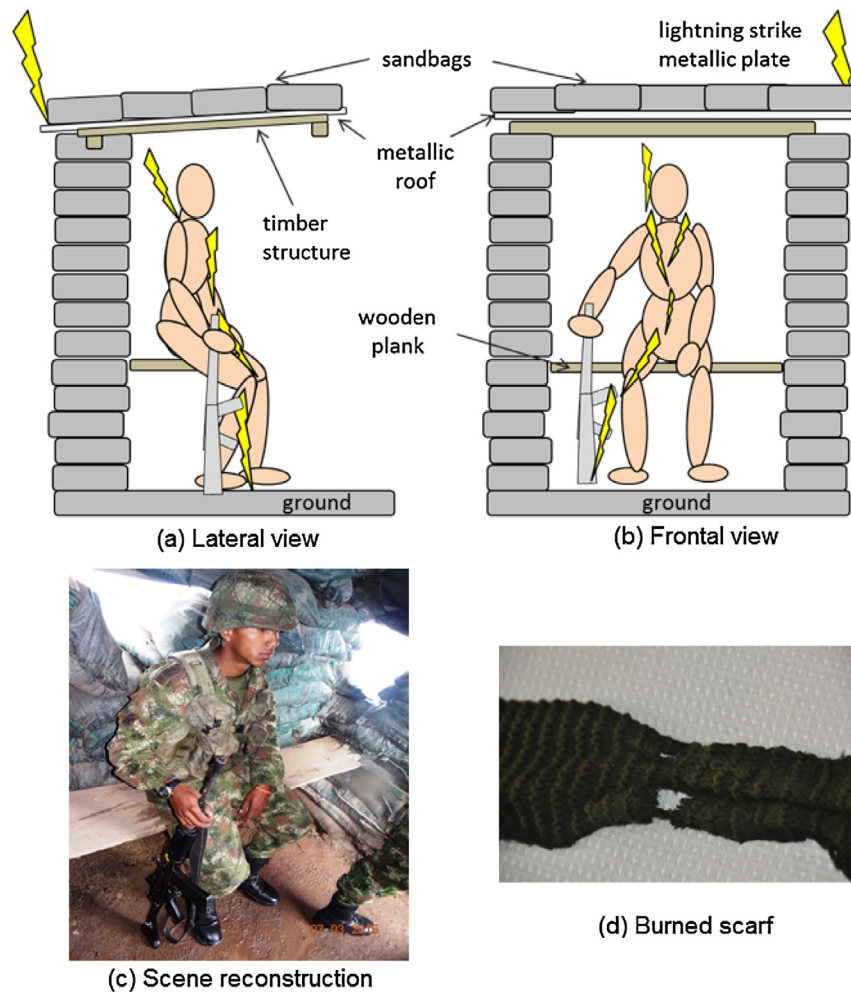
Lightning struck at the metal plate of the sandbag shelter roof with the soldier inside in declined sitting posture. The current flowed along the metal plate and across the sandbags wall until it reached the soldier's neck, leaving a burning hole in the man's scarf (see Fig. 6(d)), and flowing through the necklace. The instantaneous overheating of the necklace melts it, and left in the nape and chest of the soldier superficial and deep thickness linear burn marks. The melted necklace exploded in small pieces leaving most of overheated necklace small spheres remained on its sweatshirt (see Fig. 7(d)). The discharge path flowed from the necklace to the belt buckle and finally went out through his lateral right leg, below the knee, reaching the soldier's rifle.

**Fig. 6.** Sketch recreation of Case B scenario in lateral (a) and frontal view (b) in which a man inside of a hilltop sandbag shelter was struck by a lightning where it is shown the flashover path. In (c) a soldier illustrates the victim's actual position and in (d) a detail of the burned scarf.

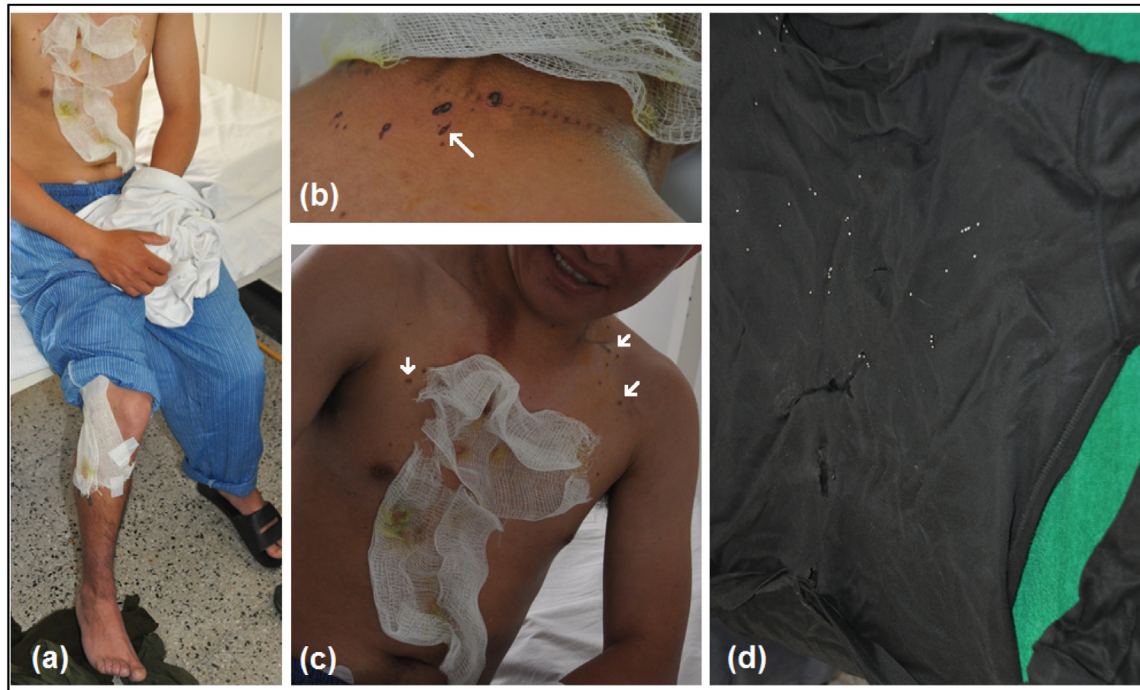
As in Case A, the current discharge was superficial avoiding injuries or damage in the soldier's vital organs. Most of the lightning current branch was probably conducted along the metal necklace avoiding it to enter into the victim's body. The molten necklace caused puncture-like deep thickness burn marks on the soldier's skin, around the neck and in the left side of his chest, as it is indicated by the arrows in Fig. 7(b) and (c).

From the necklace, the indirect lightning current flows toward the belt buckle leaving linear burns between the chest and the waist and some superficial and deep burns in both the input and the output of the discharge. Moreover, a burned point in the area of its

**Fig. 7.** Consequences of the lightning event in Case B: burns in the victim's trunk and right lower limb (a) and in his nape (b) and chest (c). The indirect lightning current flowed through his necklace, reaching the buckle belt and went out below its right knee. Note the puncture-like burned marks in the nape area and chest in (b) and (c) due to the overheated metal necklace spheres remained trapped inside the soldier's sweatshirt (d).

In Case B, due to the low temperature and humidity content of the environment at the high altitude accident scenario, the sweat and moisture of the man's body is low. Then, linear burns marked in the man's skin, because of a flashover path directed by the necklace toward the metallic belt buckle and finally toward the right knee area, close to the rifle. Thus, thermal burns by contact were produced in the victim's skin leaving superficial partial thickness marks by the overheated necklace, and later, after it burst, punctate-like deep partial thickness burns left by the overheated small spheres trapped between the sweatshirt and the skin.

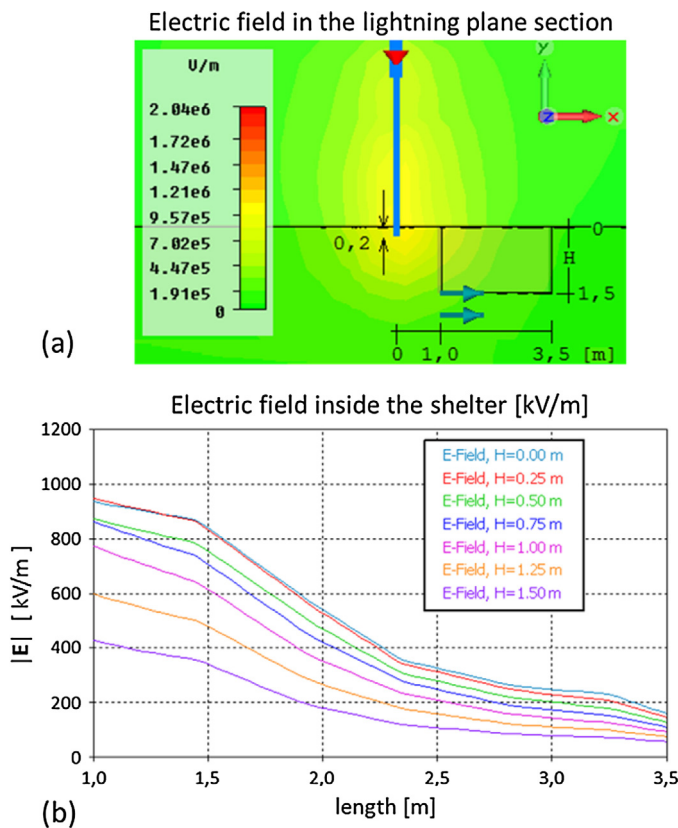
Fig. 9(a) shows the CST calculated electric field intensities produced by the lightning current inside the shelter while Fig. 9(b) shows the variation of the electric field along the horizontal lines showed in Fig. 8(d), as a function of the horizontal distance from the shelter wall. These results allow to estimate the regions in the shelter where the air breakdown electric field is exceeded.

Fig. 9(b) shows how at the shelter wall (length = 1 m), the electric field increases from the bottom to the surface. Particularly, electric field magnitudes of 900 kV/m were calculated at  $H=0,75$  m, the middle plane of the shelter wall where the victim was resting. This high electric field could easily initiate negative streamers at the shelter wall. The top view of the calculated electric field distribution is shown in Fig. 10(a). It can be observed in this figure that the highest electric fields are closer to the strike point. This result is also observed in Fig. 10(b) which corresponds to a perspective view of the electric field distribution inside the shelter for a constant height of 0,75 m.

**Fig. 9.** (a) CST calculated electric field intensities produced by a 100 kA, 10/350  $\mu$ s lightning current inside the shelter in the lightning plane and (b) variation of the calculated electric field along the horizontal lines shown in Fig. 8(d). Notice the calculated electric field magnitudes of several hundreds of kV/m obtained at the shelter wall. These fields could initiate streamers inside the shelter.

According to the simulation results for Case A, the electric field at the shelter wall was about 900 kV/m. This high electric field could initiate negative streamers. In spite of this, for electric field calculation, soil breakdown was not considered. Knowing that the critical breakdown field is about 600 kV/m for the sand-clay soil type and 300 kV/m for a soil with 0.01 S/m of conductivity [18], soil breakdown could be expected. This effect is more critical in the case when a metallic sphere is located inside the shelter. This sphere produces

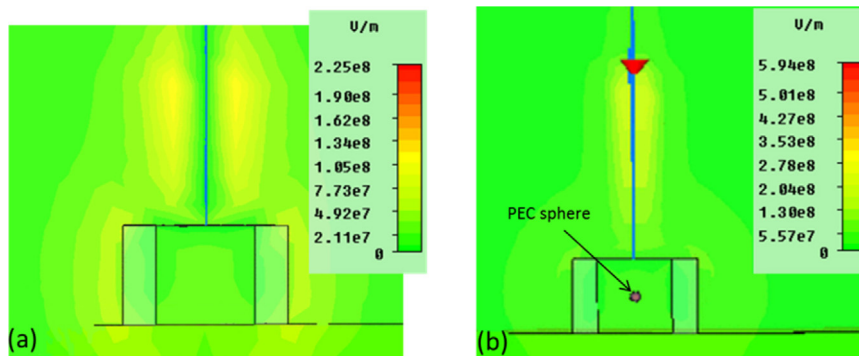
Fig. 15 shows the electric field magnitudes obtained for two simulation conditions: empty sentry box and sentry box with a perfect electric conductor sphere in its center. Inside the shelter without sphere, the electric field reaches more than 30 MV/m and with sphere is intensified above to 50 MV/m. It is noticeable the

The simulation about Case B shows that floating electrodes, as the ungrounded metallic sheet used as roof, could intensified the electric field below it far above hazardous levels. There are some other reported cases linked to floating electrodes, such as ungrounded metallic roofs or structures [21,29,30], involving multiple injured persons with fatal and nonfatal consequences. Shelters with electrically isolated metallic roofs (as sentry boxes, newsstands, kiosks, gazebos or rotundas) are not safe against lightning discharges.

**Fig. 15.** CST electric field calculation produced by a 100 kA, 10/350  $\mu$ s current impulse for an empty sentry box (a) and a sentry box with a perfect electric conductor (PEC) sphere inside (b). Note the strong intensification of the absolute value of the electric field due to the PEC sphere.
