**Master's degree in civil engineering**

**SHEAR BEHAVIOR OF POST-INSTALLED ANCHOR  
CONNECTIONS STRENGTHENED WITH CFRP LAMINATES**

**Bogotá, D.C., July 18<sup>th</sup>, 2024**

**Thesis to Attain a Master's Degree in Civil Engineering with  
Emphasis in Structural Engineering**

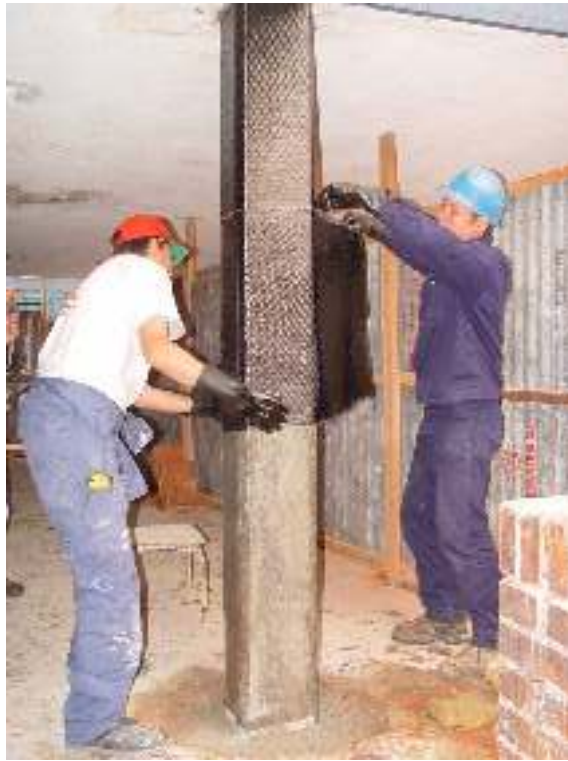
**Figure 2** FRP jacketing of a column. Source: (Rendón, 2016, p. 18)

It is evident that among local measures, jacketing is an alternative with positive effects on the strength and ductility of the reinforced members. For instance, external reinforcements that incorporate fiber-reinforced polymers (FRP), improve the flexural, shear and axial response of reinforced members. One of the main advantages of FRP is its faculty of adapting to the existing member geometry, providing an effective confinement. For example, it is common to encounter columns reinforced with FRP, which increases their compressive and flexural strength. An illustration of this reinforcement system is presented in Figures 2 and 3:

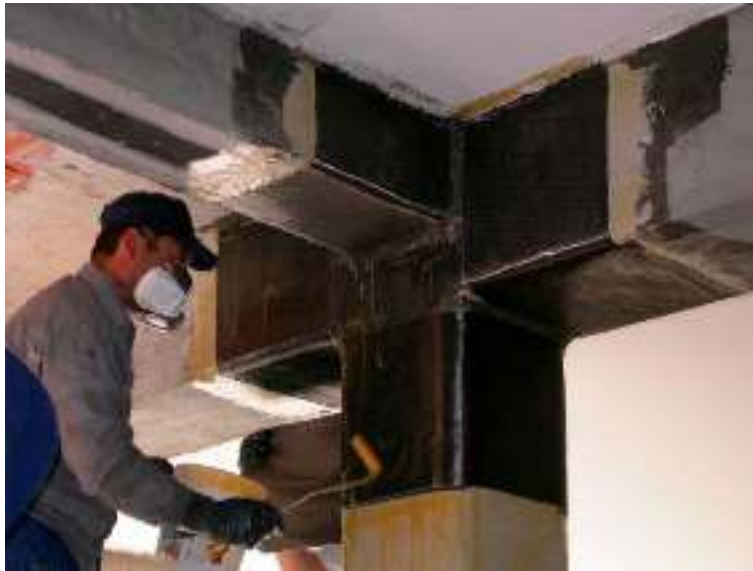
**Figure 3** Strengthening of a beam-column connection with FRP laminates. Source: (Rendón, 2016, p. 121)

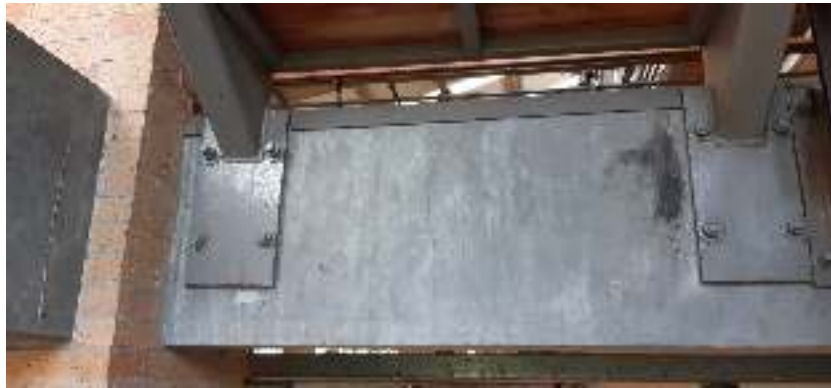
**Figure 4** *Steel staircase connected and supported by a concrete beam. Source: Own.*

Additionally, there are instances in which the selected retrofitting alternative involves connecting new elements to the existing ones. Over the last decades there has been a substantial increase in the use of post-installed anchors. However, these fastening systems are not limited to retrofitting strategies; they are also employed in new construction and in non-structural applications. For example, Figure 4 shows the connection between a steel staircase and a concrete beam. In that instance, the anchors are subjected to shear.

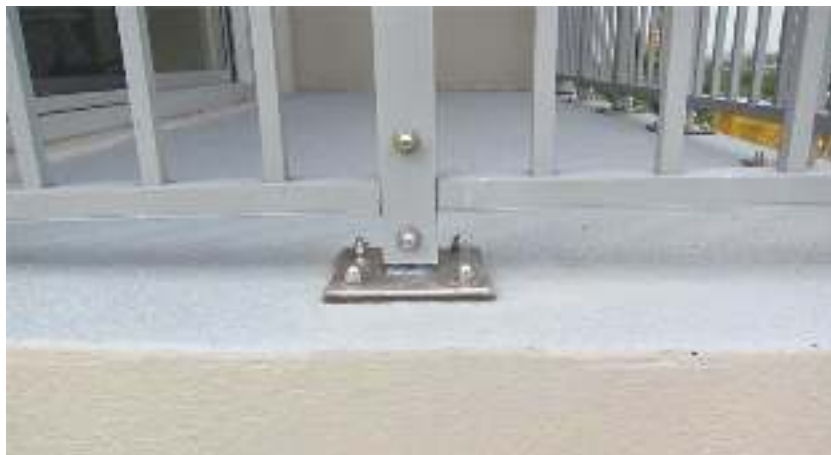
**Figure 5** *Metallic railing anchored to a concrete slab. Source: (Haukohl et al., 2019)*

As mentioned before, anchors are also used in non-structural applications, such as in railings and façades, where they may be subjected to shear, bending, or a combination of both (Figure 5).

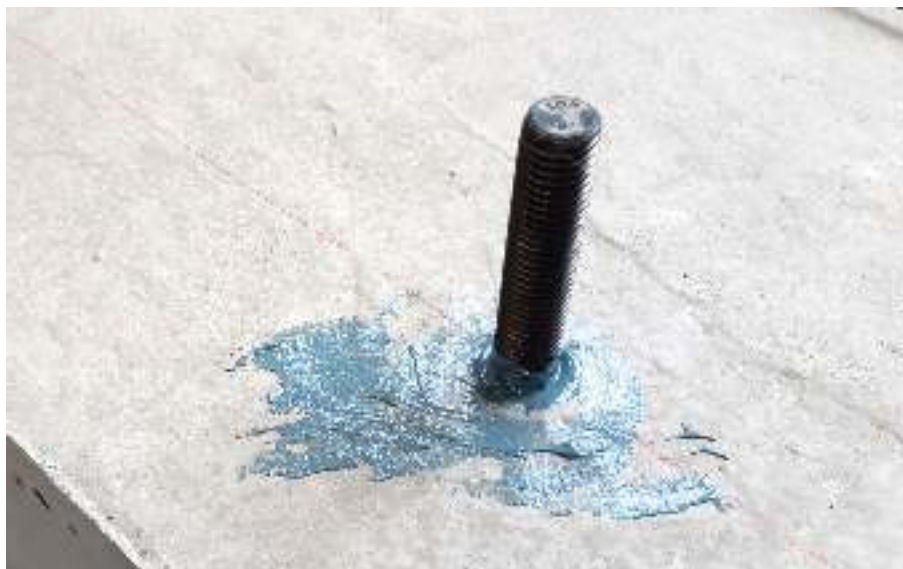
**Figure 18** *Installation of a bonded anchor. Source: Own.*

The installation of the anchors was done by certified technicians, following the recommendations given in the technical specifications of the epoxy. Figure 18 illustrates this process.

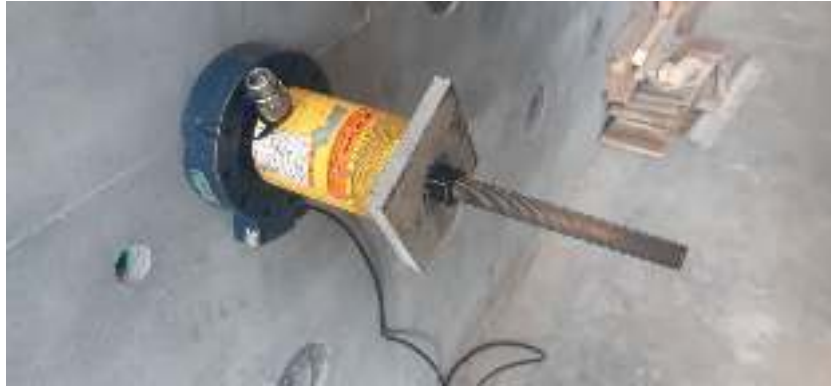
A 300 kN hydraulic jack was employed to generate the external shear load (Figure 19):

**Figure 19** *Hydraulic jack used for testing. Source: Own.*

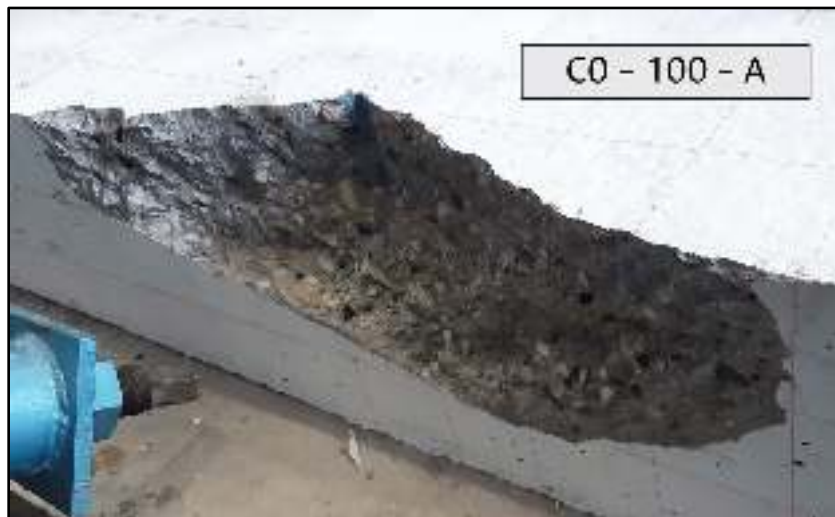
**Figure 25** Failure surface C0 – 100 – A. Source: Own.

Furthermore, Figure 25 shows the failure surface after specimen A reached failure:

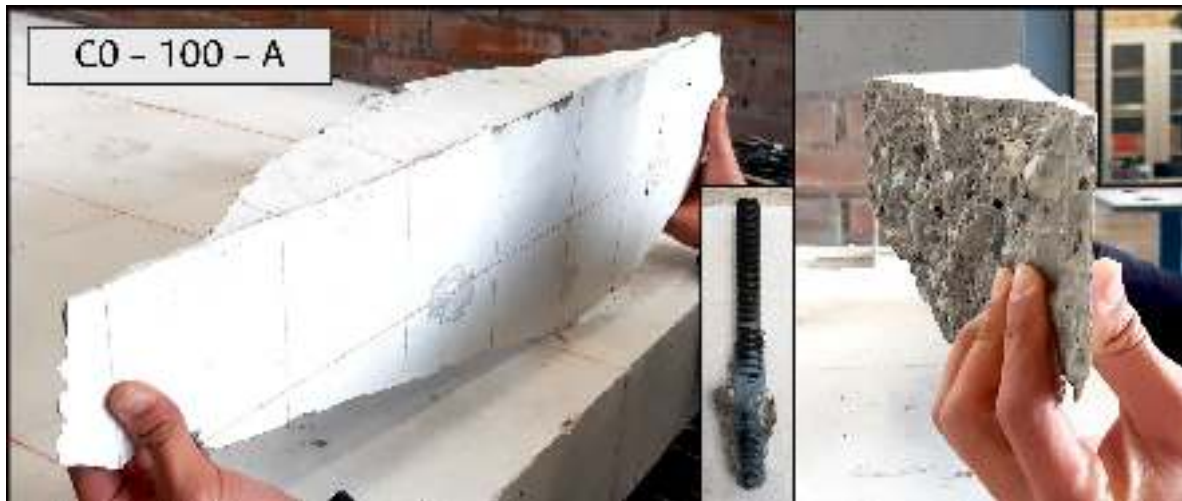
**Figure 26** Concrete breakout body C0 – 100 – A. Source: Own.

On the other hand, Figure 26 shows the concrete breakout body and the final state of the anchor that corresponded to specimen A:

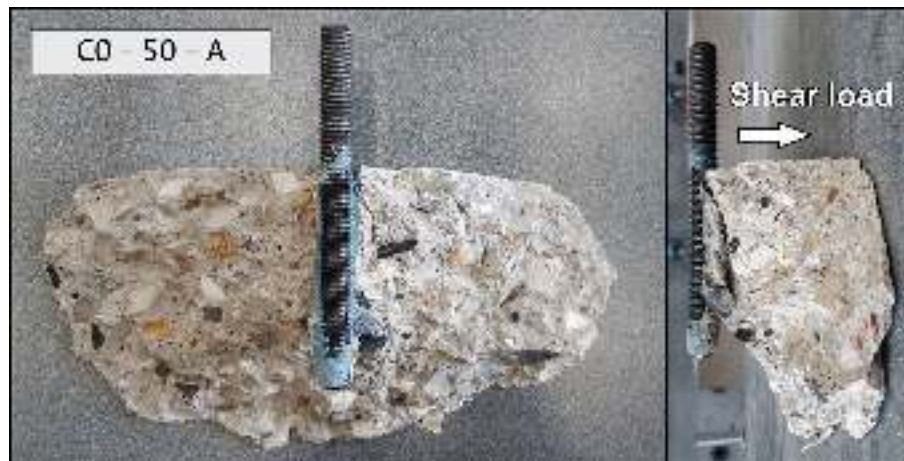
**Figure 29** Concrete breakout body C0 – 50 – A. Source: Own.

Most of the details related to the failure mechanism of these specimens have been discussed in the previous sections, this section will evidence the state of the specimens after failure, as well as the crack orientation analysis. Figure 29 shows the breakout body of specimen A:

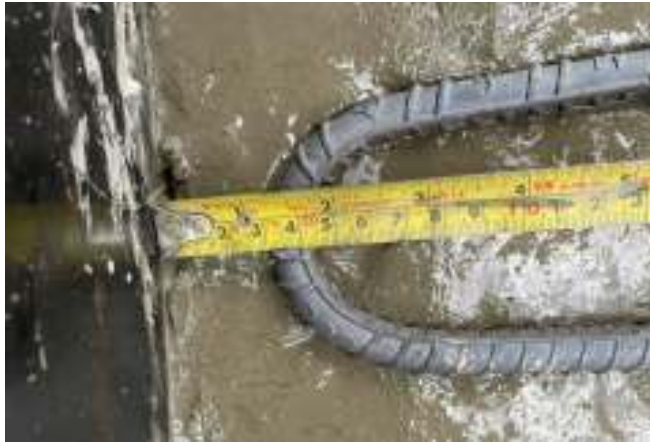
**Figure 30** *Hairpin installation to guarantee contact with the anchor. Source: Own.*

The installation of hairpins involved great attention to detail. As reviewed in the theoretical framework, the response of hairpin-reinforced anchors depends on great measure, of the quality of the installation. Minimum top cover of 25 mm (1 in) was guaranteed, as well as contact between the anchor and the specimen. It was also verified that the hairpin was leveled within the concrete mass. Evidence of this work is illustrated in Figures 30 and 31:

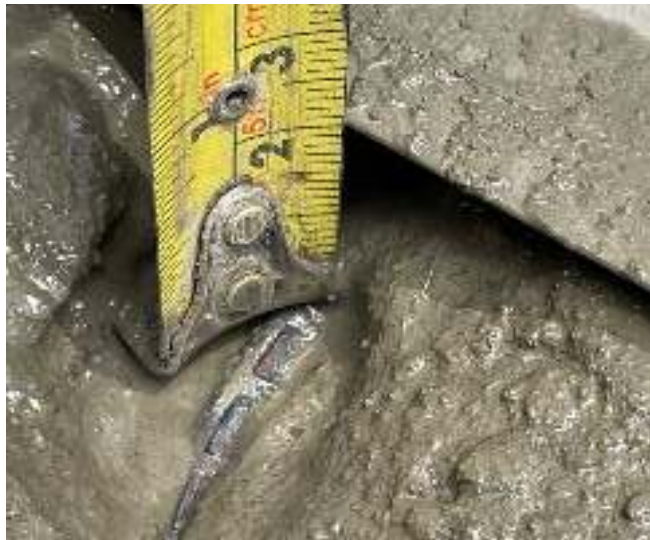
**Figure 31** *Hairpin installation guaranteeing minimum concrete cover. Source: Own.*

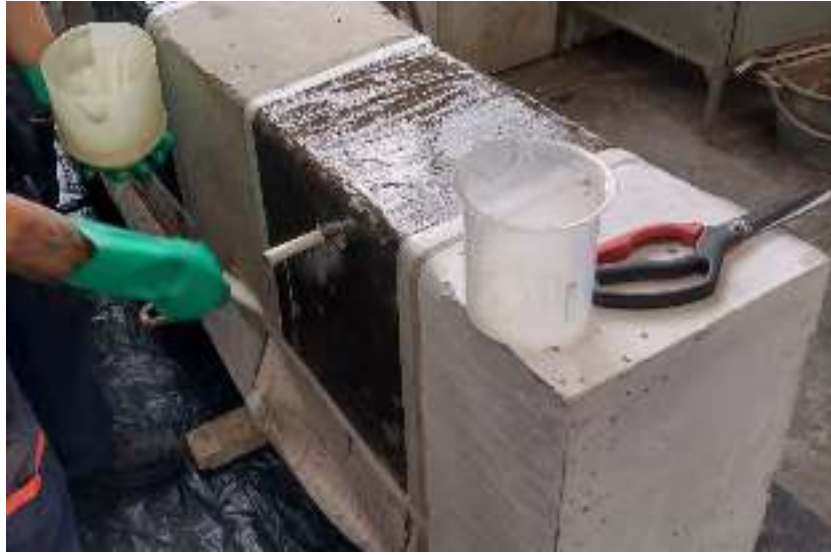
**Figure 32** *Application of filling putty to guarantee uniformity of the concrete region in contact with the CFRP. Source: Own.*

All CFRP laminates were installed by certified technicians, following the procedures recommended by the manufacturer and exercising good practice techniques (Figures 32 and 33):

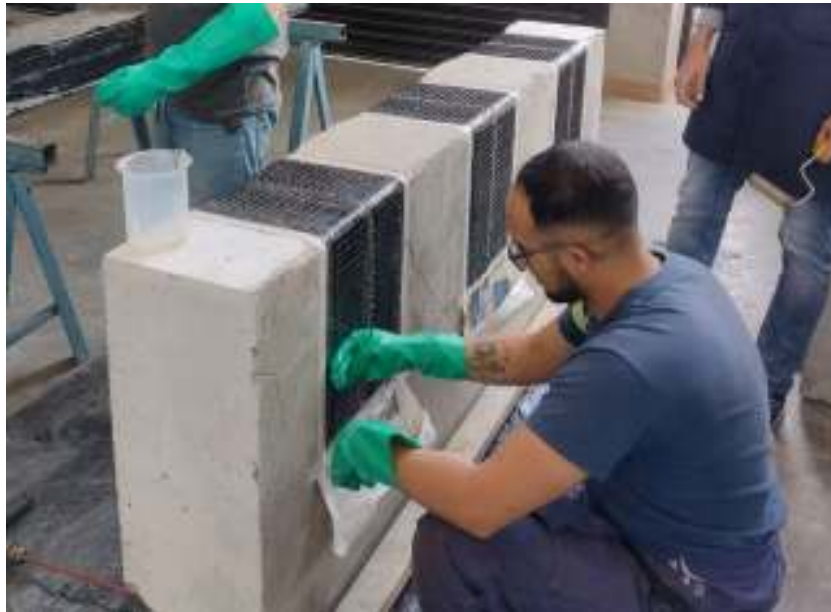
**Figure 33** *CFRP installation. Source: Own.*

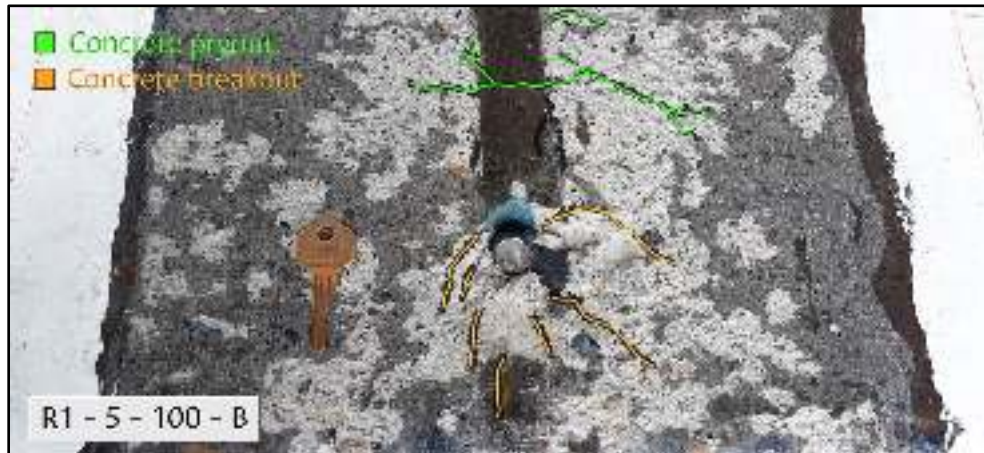
**Figure 59** Failure mechanism R1 – 5 – 100 – B. Source: Own.

Besides, to get a deeper understanding of the failure mechanism, the CFRP was retired once the test ended, as shown in Figure 59 for specimen B:

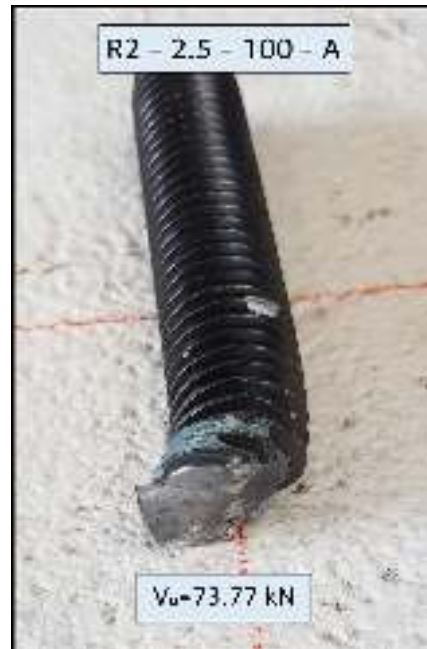
**Figure 64** Anchor failure R2 – 2.5 – 100 – A. Source: Own.

The failed anchor and the crack analysis of specimen A are presented in Figures 64 and 65, respectively.

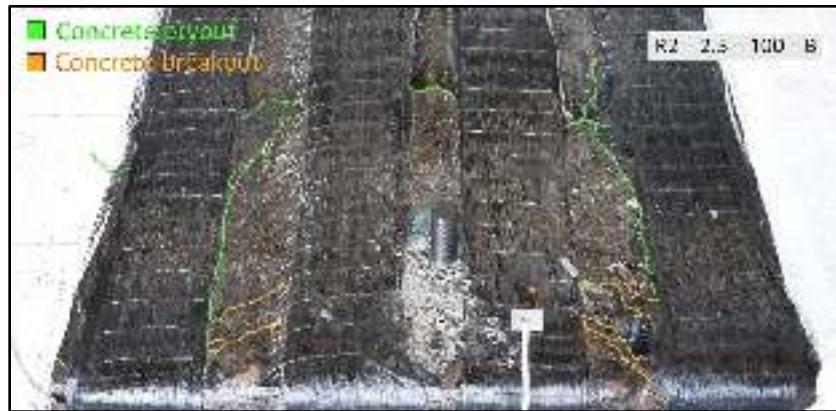
external laminates and the concrete, advancing toward the edge of the slab. Once these cracks intersected with some concrete breakout cracks formed previously, the concrete pryout body could rotate freely, thus, the system could not bear any significant load. The crack pattern of specimen B is presented in Figure 68:

**Figure 68** Failure mechanism R2 – 2.5 – 100 – B. Source: Own.

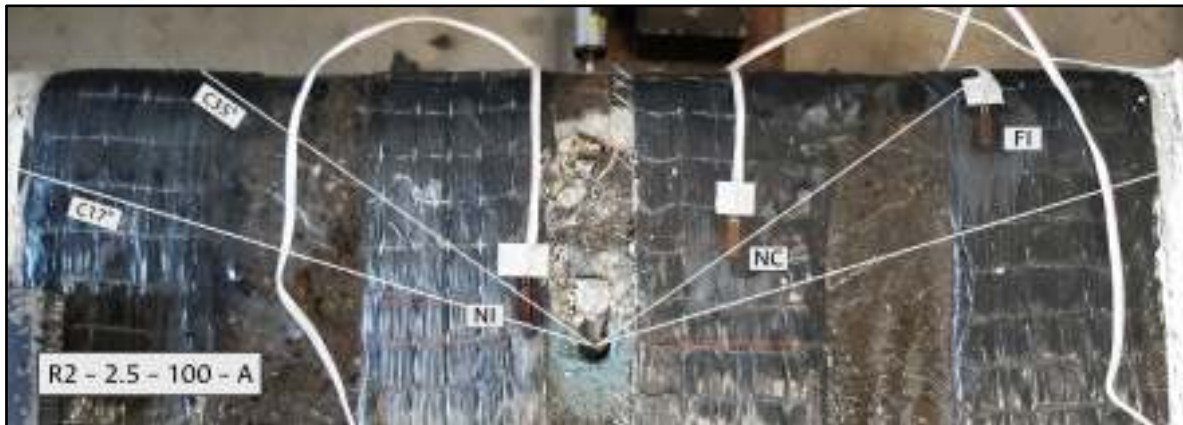
**Figure 70** Strain gauges placement R2 – 2.5 – 100 – A. Source: Own.

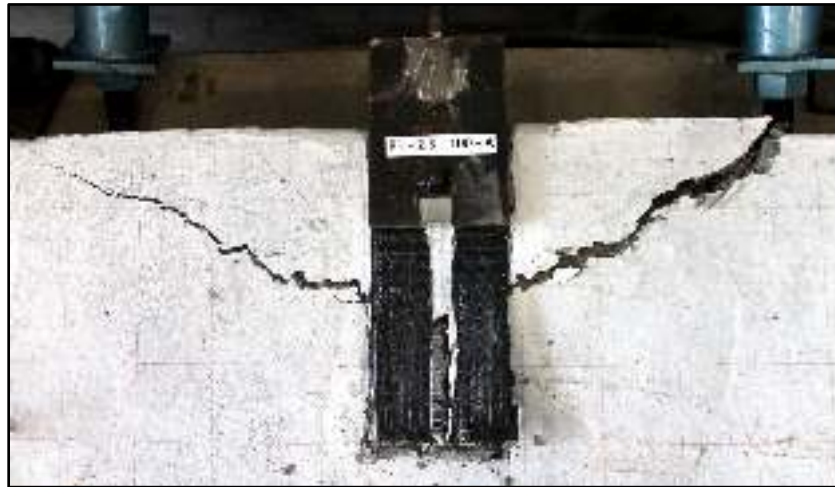
**Figure 74** Crack formation in specimen *R1 – 2.5 – 100 – A*. Source: Own.

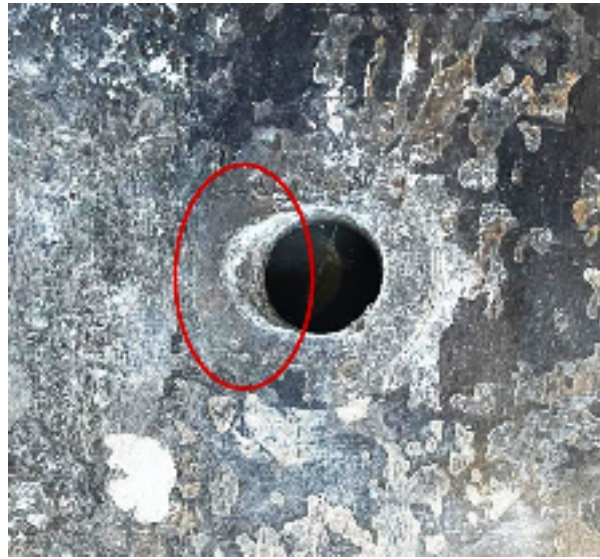
**Figure 76** Wear on the steel plate due to accumulated tests. Source: Own.

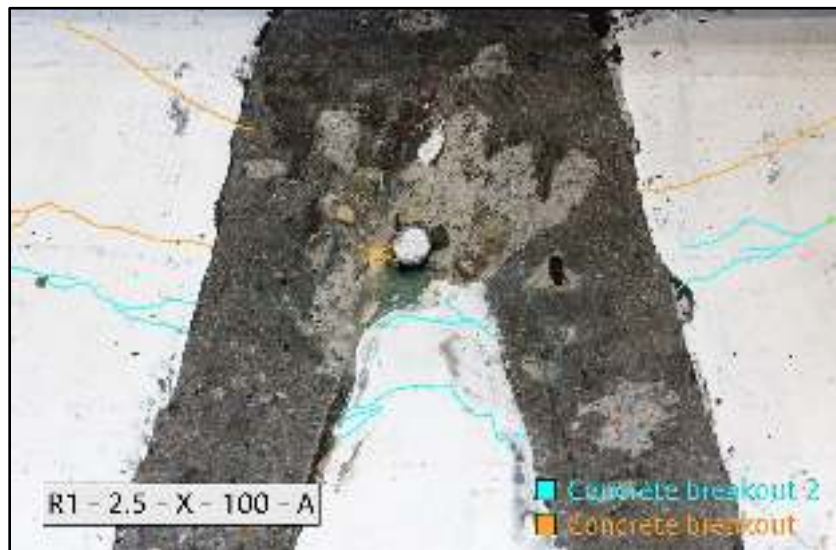
**Figure 77** Failure mechanism R1 – 2.5 – X – 100 – A\*. Source: Own.

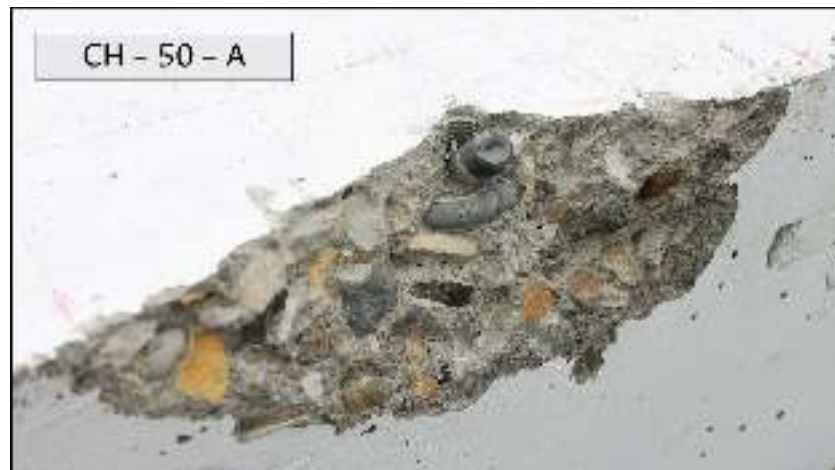
**Figure 83** Failure mechanism CH – 50 – A\*. Source: Own.

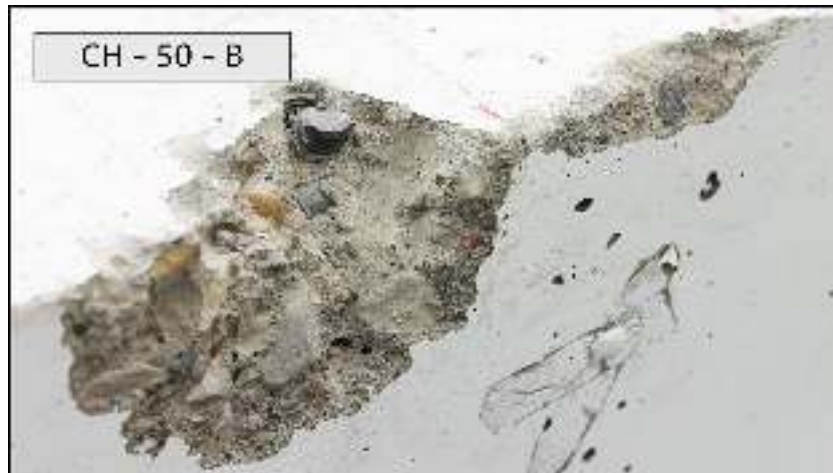
**Figure 84** *Failure mechanism CH – 50 – B\*. Source: Own.*

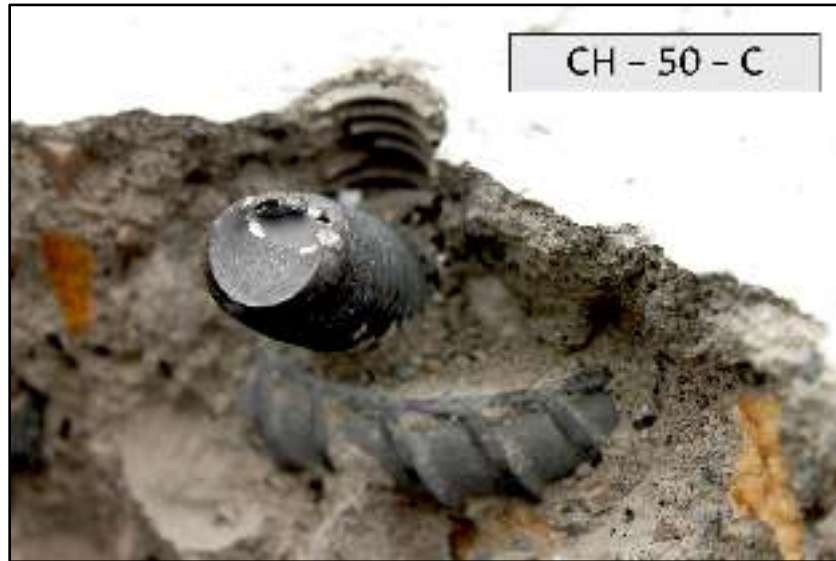
**Figure 85** Failure mode CH – 50 – C\*. Source: Own.

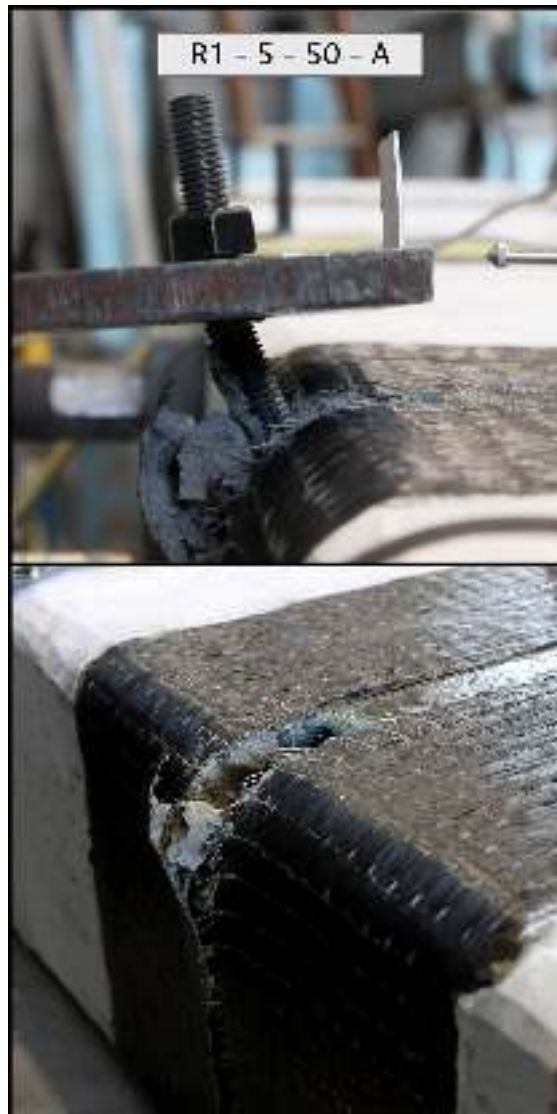
**Figure 87** Failure mode R1 – 5 – 50 – A. Source: Own.

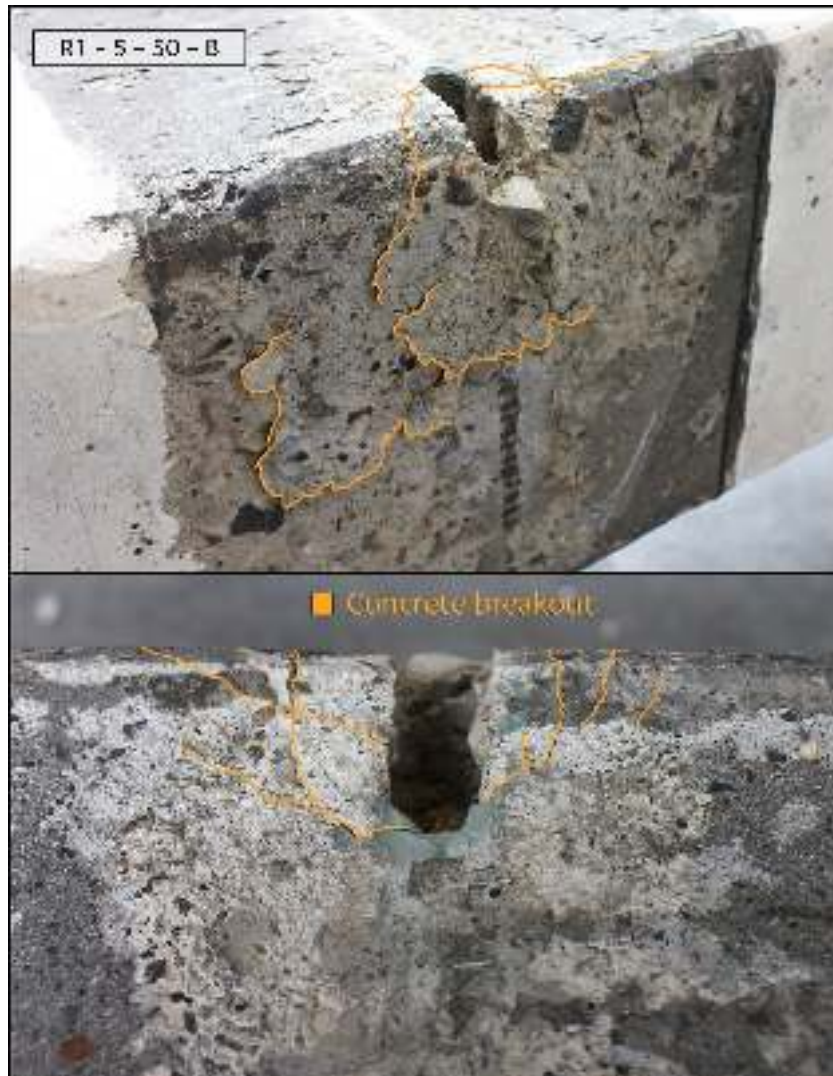
**Figure 88** Failure mode R1 – 5 – 50 – B. Source: Own.

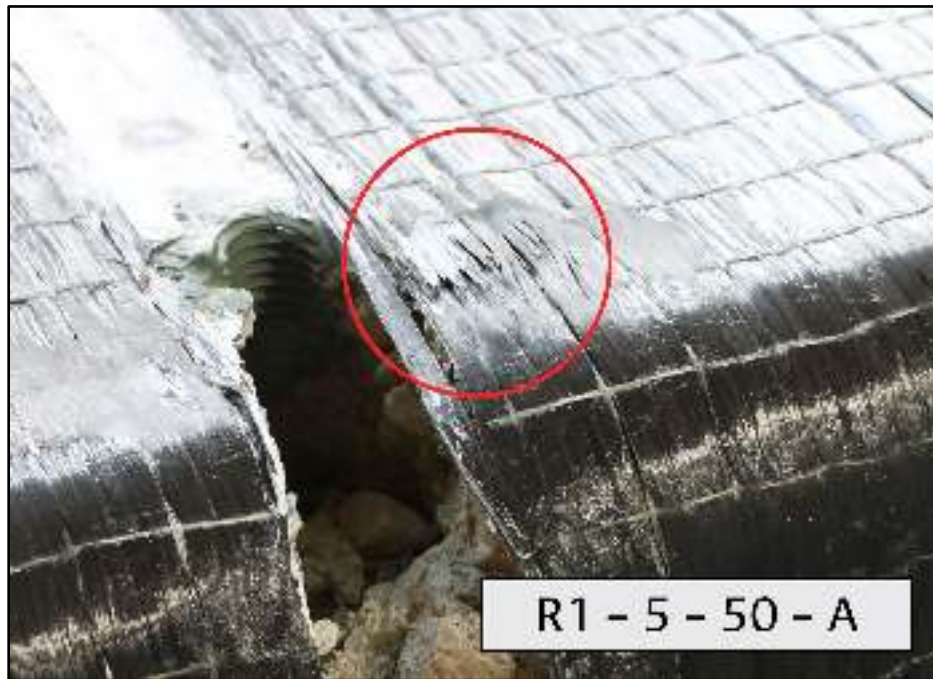
**Figure 89** CFRP rupture R1 – 5 – 50 – A. Source: Own.

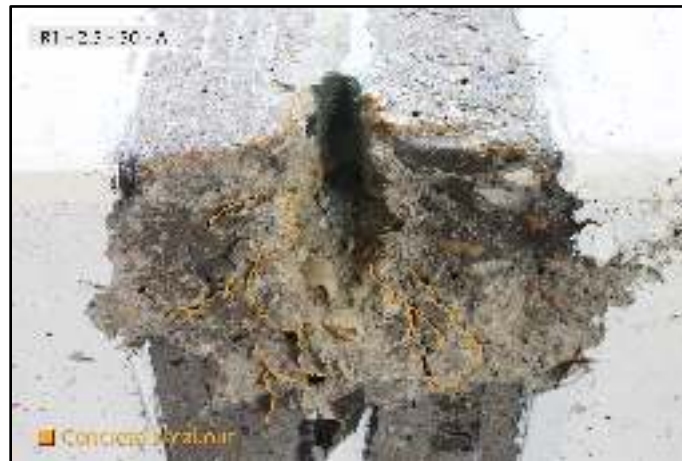
**Figure 94** Failure mode R1 – 2.5 – 50 – A. Source: Own.

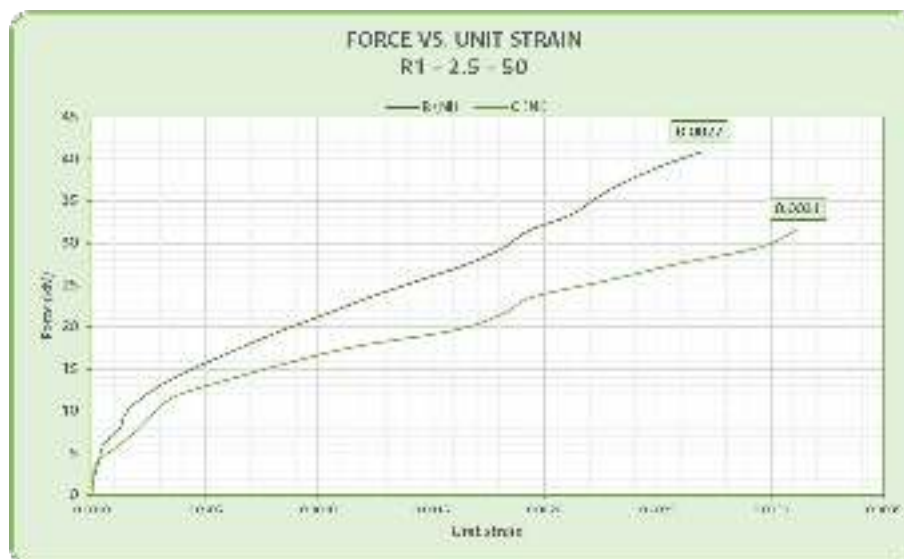
**Figure 96** Force vs. unit strain  $R1 - 2.5 - 50$ . Source: Own.

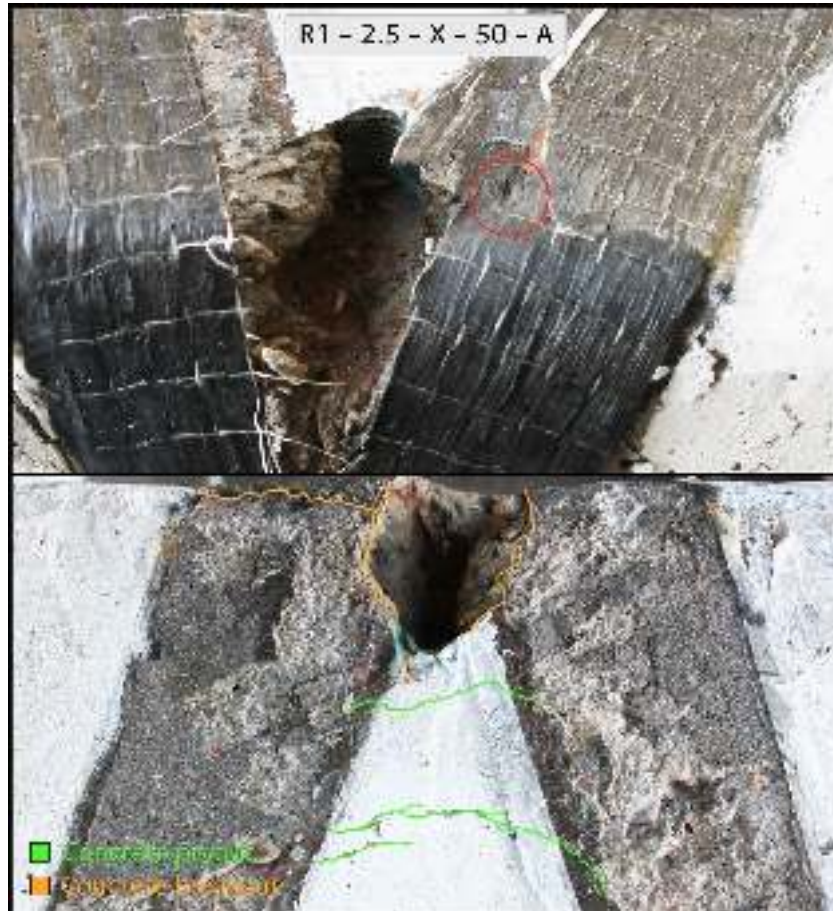
**Figure 98** Failure mode R1 – 2.5 – X – 50 – A\*. Source: Own.

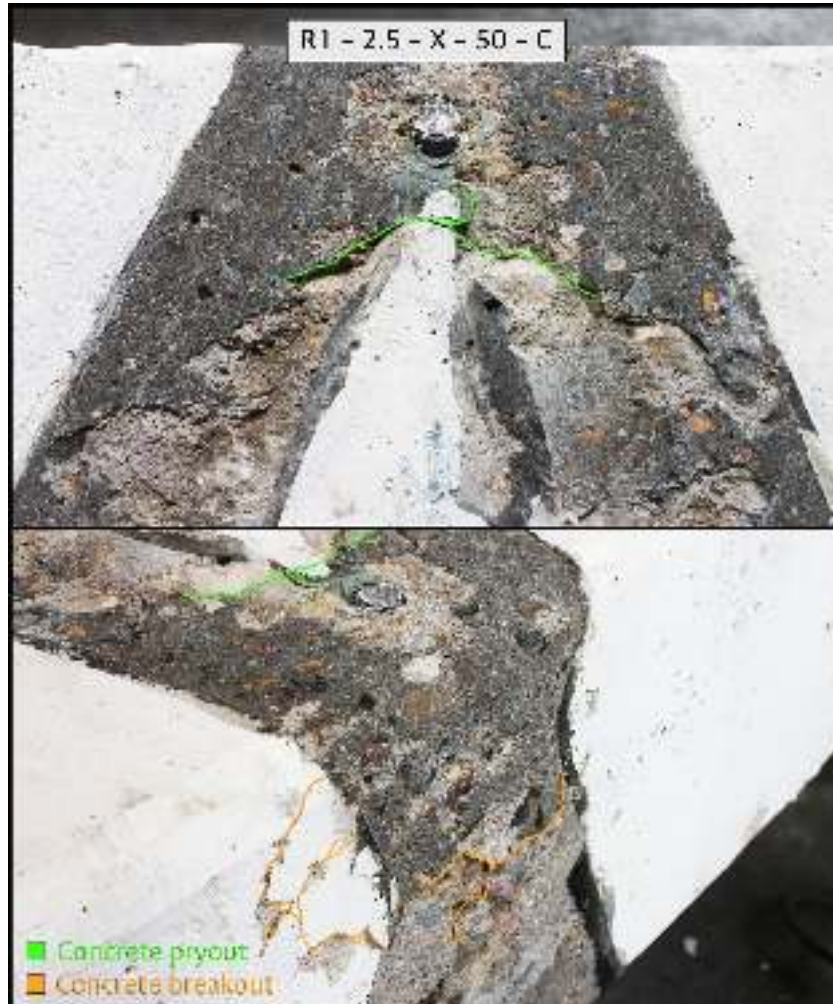
**Figure 99** Failure mode R1 - 2.5 - X - 50 - C\*. Source: Own.

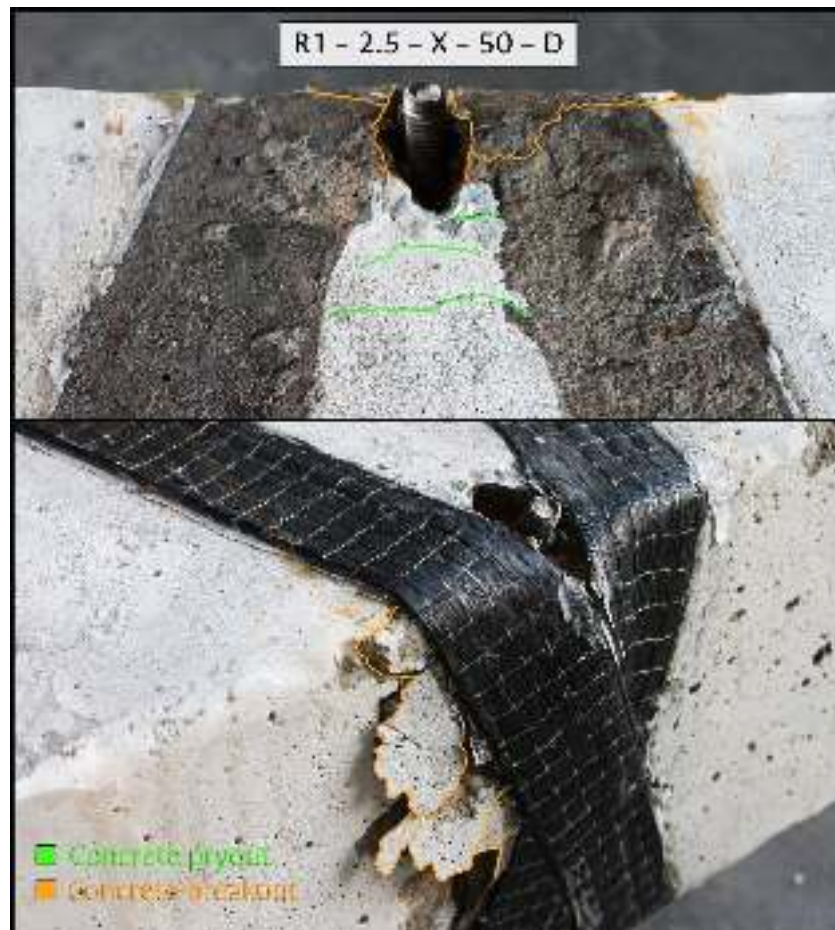
**Figure 100** Failure mode R1 – 2.5 – X – 50 – D\*. Source: Own.
