# Analysis of two nonfatal lightning accidents in Colombia

Several lightning accidents involving human fatalities and injuries are reported every year in Colombia. This work presents and discusses two non-fatal lightning accidents, where the victims survived without evident permanent disabling traumas. In both cases, it was observed that metallic objects such as necklaces or buckle belts worn by the victims were intercepted by the lightning current. These metallic objects could possibly be a pathway to keep the lightning current on the victim's skin surface. To understand the interaction of these metallic objects and the indirect lightning currents, both the visual consequences of the indirect lightning current on the victim's skin and a comprehensive description of the cases scenarios are presented.

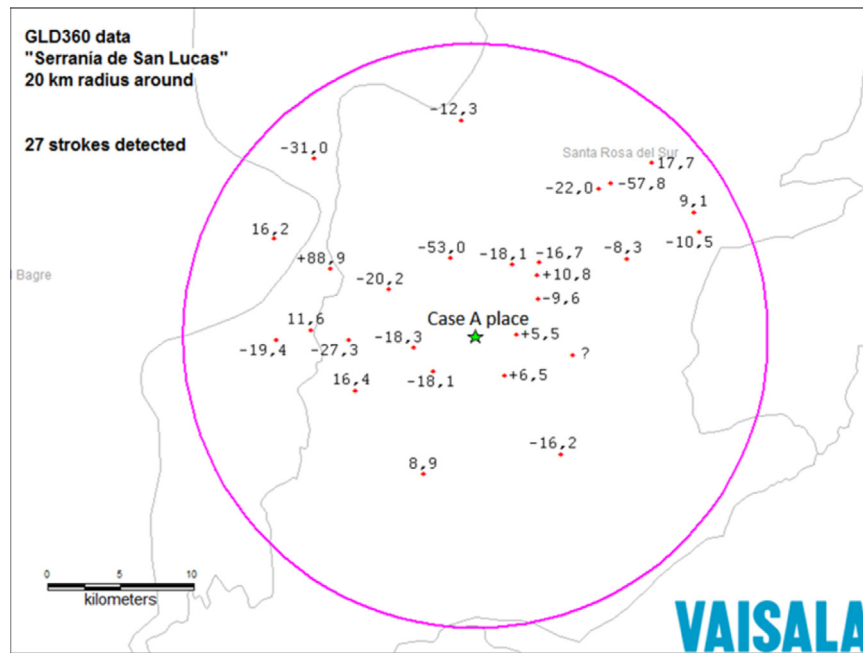
According to GLD360 data of Vaisala, in the lapse of time between 19:00 h and 20:00 h on a radius of 20 km around the site, the area was struck at least by 27 strokes with currents between −57,8 kA and +88,9 kA as shown in Fig. 3 (Holle R., personal communication, October 20, 2016). According to the accident's local time reported and to the geographical uncertainties of the data set, the lightning flash current amplitude was identified as +88,9 kA.

**Fig. 3.** GLD360 lightning data from Vaisala, in the lapse of time between 19:00 h and 20:00 h on a radius of 20 km around the reported place for Case A. This area was struck by at least by 27 lightning strokes with currents between  $-57,8$  kA and  $+88,9$  kA (Holle R., personal communication, October 20, 2016).

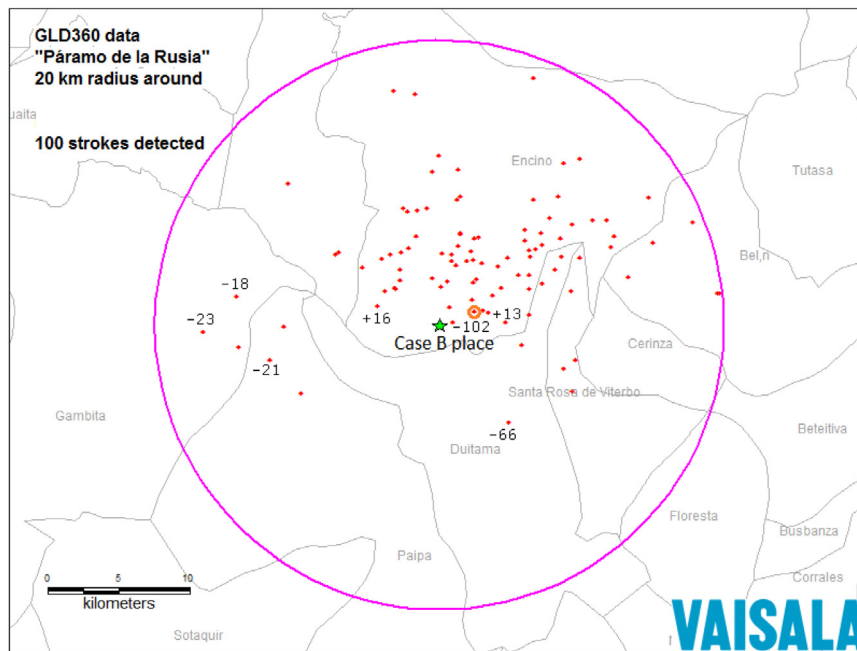
Fig. 5. Lightning strokes map for 20 km radius around the place reported for Case B. (Holle R., personal communication, October 20, 2016).

towers located on the hilltop of a 4.280 m altitude mountain. For this case, according to GLD360 data from Vaisala, between 15:00 h and 16:00 h on a radius of 20 km around the site, the area was struck at least by 100 strokes with currents between  $-101,7$  kA and  $+24,1$  kA, as shown in Fig. 5 (Holle R., personal communication, October 20, 2016).

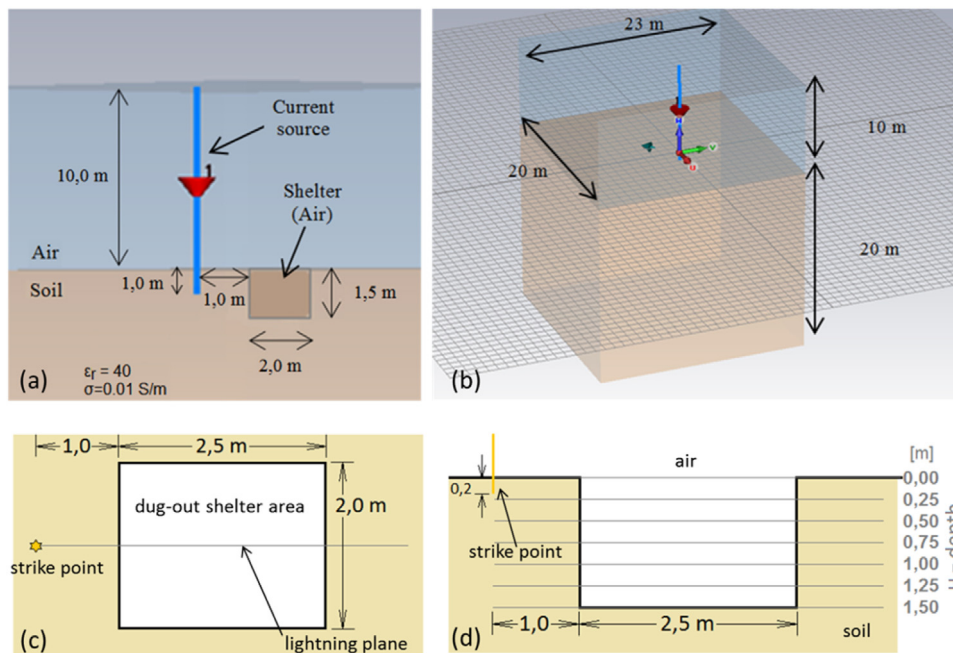
Fig. 8 shows the dimensions of the simplified scenario of Case A which was numerically simulated using the transient solver of the computer program CST Microwave Studio. Fig. 8(a) and (b) shows the respective lateral and perspective views of the shelter model. Fig. 8(c) is a top view of the shelter while Fig. 8(d) shows a cross section along the lightning strike point. In this cross section, the electric field was calculated along 7 horizontal lines, which were plotted every 0,25 m from the earth surface to the bottom of the shelter.

**Fig. 8.** Simplified scenario of Case A to calculate the electric field produced by a lightning discharge with the transient solver of the computer program CST Microwave Studio. A side view of the simulated scenario is shown in (a), the prospective view is shown in (b), and a top view is shown in (c). The cross sectional view along the Lightning strike point is shown in (d). Electric field was calculated along the parallel horizontal lines separated 0.25 m and plotted from the earth surface to the shelter bottom at 1.5 m.

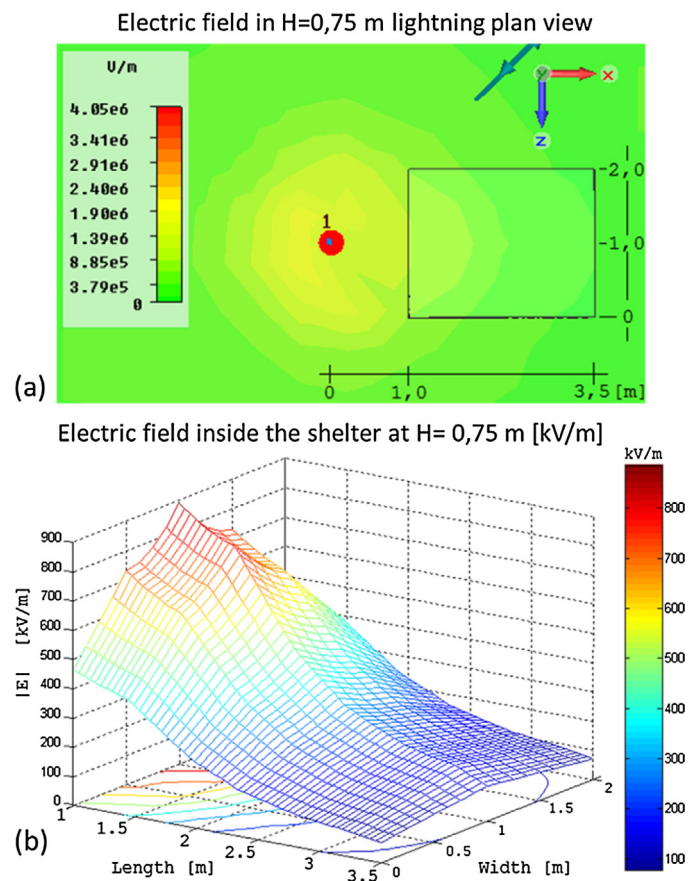
Fig. 9(b) shows how at the shelter wall (length = 1 m), the electric field increases from the bottom to the surface. Particularly, electric field magnitudes of 900 kV/m were calculated at  $H=0,75$  m, the middle plane of the shelter wall where the victim was resting. This high electric field could easily initiate negative streamers at the shelter wall. The top view of the calculated electric field distribution is shown in Fig. 10(a). It can be observed in this figure that the highest electric fields are closer to the strike point. This result is also observed in Fig. 10(b) which corresponds to a perspective view of the electric field distribution inside the shelter for a constant height of 0,75 m.

According to the simulation results for Case A, the electric field at the shelter wall was about 900 kV/m. This high electric field could initiate negative streamers. In spite of this, for electric field calculation, soil breakdown was not considered. Knowing that the critical breakdown field is about 600 kV/m for the sand-clay soil type and 300 kV/m for a soil with 0.01 S/m of conductivity [18], soil breakdown could be expected. This effect is more critical in the case when a metallic sphere is located inside the shelter. This sphere produces

**Fig. 10.** (a) Top view of the CST calculated electric field intensities inside the shelter at a height 0.75 m from the bottom produced by a 100 kA, 10/350  $\mu$ s current impulse. (b) Prospective view of the electric field distribution inside the shelter for a constant height of 0.75 m. Calculations were performed for a wet soil ( $\epsilon_r = 40$ ;  $\sigma = 0.01$  S/m). Notice that the highest electric field in the wall at 0.75 m is almost 900 kV/m. This high electric field value could initiate negative streamers in the shelter wall.

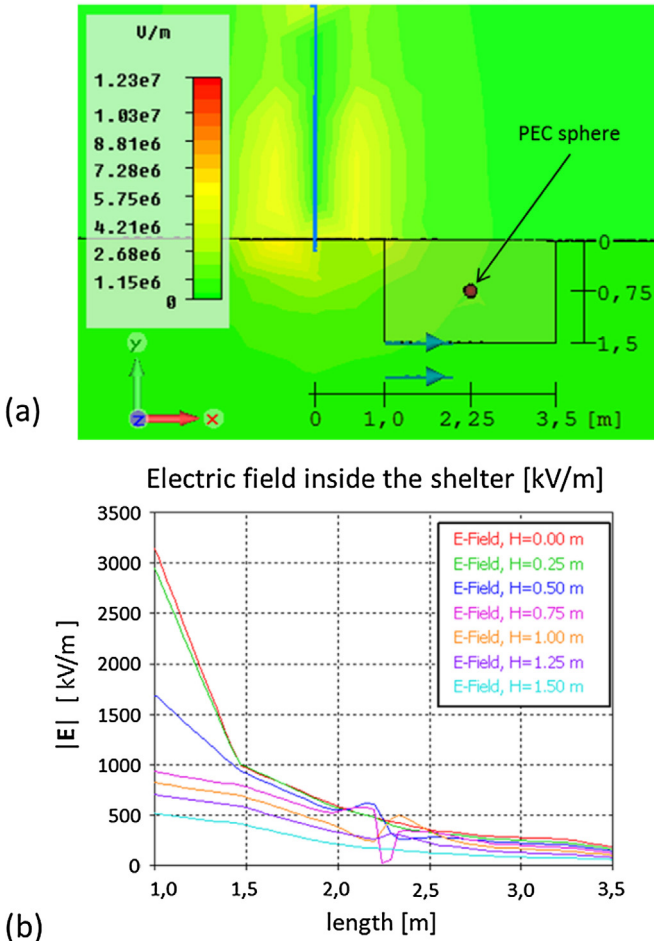
Considering that a metallic object inside the shelter could modify the electric field distribution shown in Fig. 10(b), a 0,20 m diameter perfect conducting material (PEC) sphere was simulated inside the shelter. The metallic sphere was centered in the middle of the shelter as shown in Fig. 11(a).

**Fig. 11.** (a) CST calculated electric field intensities produced by a 100 kA, 10/350  $\mu$ s lightning current inside the shelter in the lightning plane, when a 0,20 m diameter metallic sphere (PEC sphere) is placed in the middle of the shelter. (b) shows the variation of the calculated electric field along the horizontal lines shown in Fig. 8(d), but including the metallic sphere. Notice that the magnitudes of the electric field at the shelter wall increase almost three times when compared with the calculated values shown in Fig. 9(b).

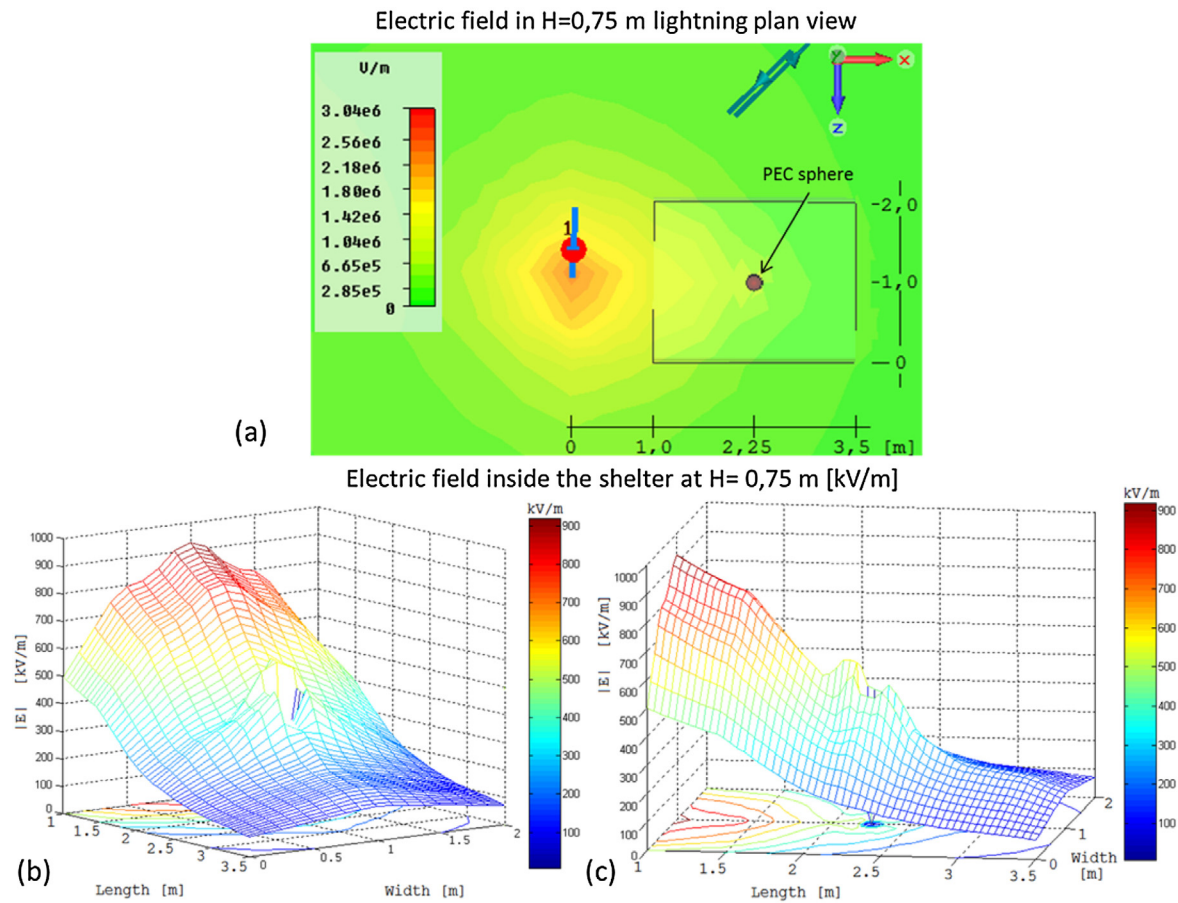
Fig. 12(a) shows a top view of the CST calculated electric field at 0,75 m height measured from the shelter bottom. Fig. 12(b) and (c) presents the calculated values with and without a PEC sphere in a perspective view at  $H=0,75$  m. Comparing Fig. 10 with Fig. 12, it is noticeable the increase of the electric field due to the presence of the metallic object. That electric field increase can be observed in Fig. 13.

**Fig. 12.** (a) CST calculated electric field intensities produced by a 100 kA, 10/350  $\mu$ s current impulse, when a metallic sphere is placed in the center of the shelter at 0,75 m from the bottom; (b) and (c) are perspective views of the same calculated electric field inside the shelter at 0,75 m from the shelter bottom.

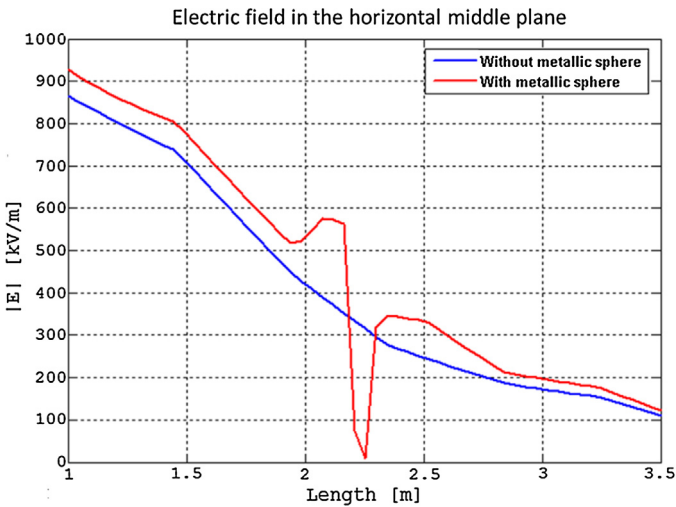
**Fig. 13.** CST calculated electric field intensities inside the shelter at 0.75 m from the bottom produced by a 100 kA, 10/350  $\mu$ s current impulse, with and without a metallic sphere. Notice the electric field enhancement except inside the sphere placed in the middle of the shelter, where its value is zero.

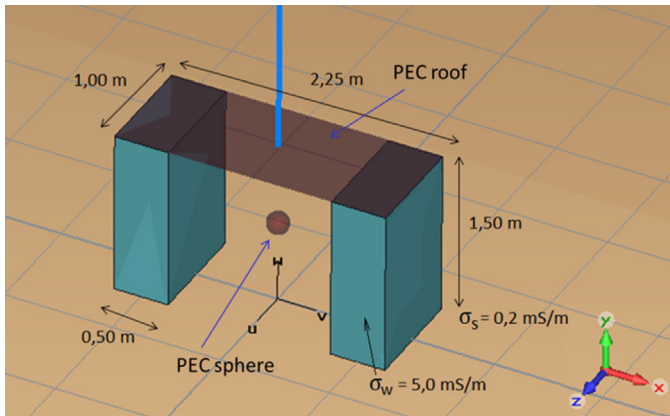
The electric field calculation of sentry box shelter of Case B was also performed using a 100 kA, 10/350  $\mu$ s current source and taking the conditions considered for Case A. Fig. 14 shows the dimensions of the simplified scenario model. The shelter roof was simulated as a perfect electric conductor material and the walls were assumed as made of sand with a conductivity of 5,0 mS/m, while the soil conductivity was assumed as 0,2 mS/m. As in Case A, the electric field distribution inside the sentry box was calculated with and without a 0,2 m diameter PEC sphere.

**Fig. 14.** Simulation setup of the sentry box type shelter for the CST electric field calculation.
