# A New Module for the Evaluation of Bridges Based on Visual Inspection through a Digital Application Linked to an Up-to-Date Database of Damage Catalog for Colombia

**Abstract:** Road structures undergo a series of chemical and physical processes once they are put into service. This phenomenon results from the action of the load and the influence of the environment, which causes their progressive deterioration. In order to mitigate the risk of progressive deterioration and guarantee their stability and durability, various maintenance tasks are required, including visual inspections. The Intelligent Bridge Management System of Colombia (SIGP) includes visual inspection as one of its modules. The system has been designed based on state-of-the-art criteria and national experience with relevant damages and bridge collapses. This paper presents the visual inspection methodology, which includes several stages such as a classification scale, condition index, evaluation areas, damage catalog, and evaluation criteria. In addition, a digital application has been developed to facilitate real-time data collection during field inspections using mobile devices, which can be uploaded directly t

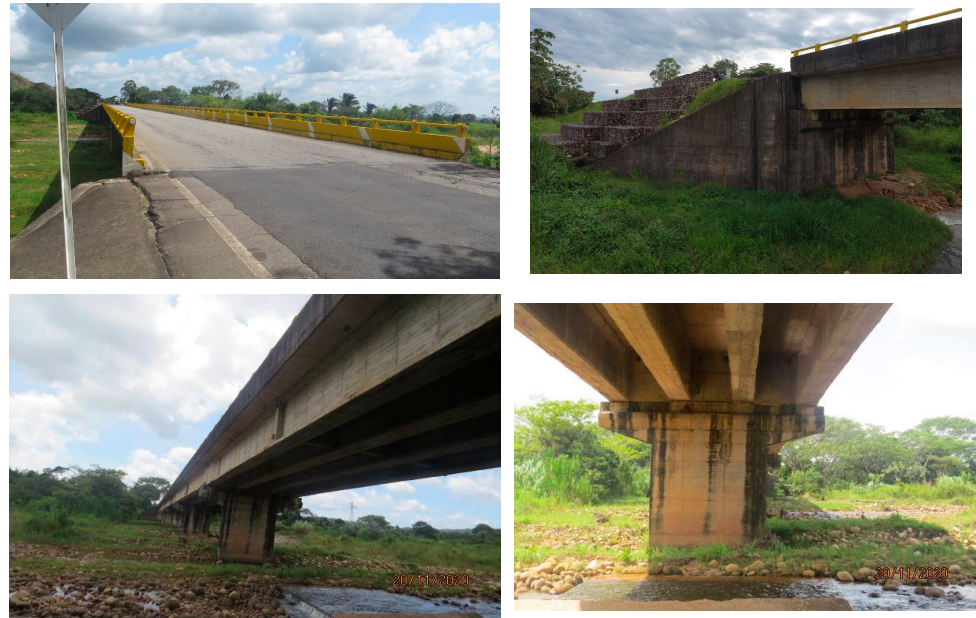
application of the methodology. The Guacharí Bridge is located on the Paz de Ariporo highway in Yopal, Casanare, Colombia. The bridge was built in the 1970s, and its typology includes five simply supported spans, consisting of a deck and slab in prestressed concrete. It has four reinforced concrete piers of the wall type with header beams and two abutments, also of reinforced concrete, with shallow foundations (see Figure 9).

**Figure 9.** Guachiría Bridge typology.

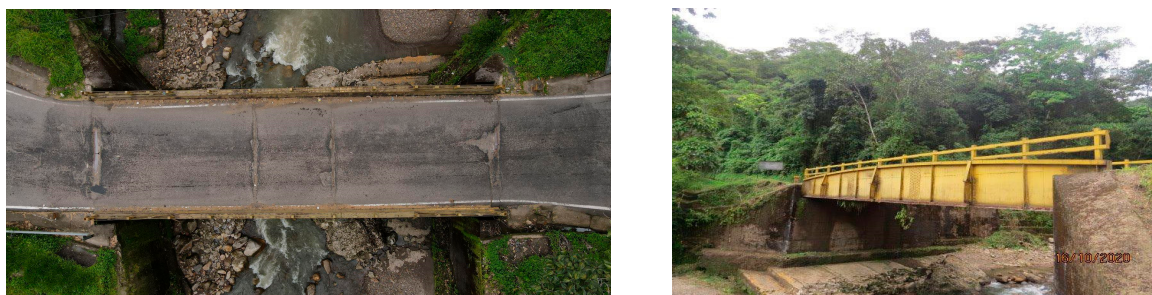
The Chichaca Bridge, which is the second bridge, also belongs to the Casanare area and is located on the Yopal-Paz de Ariporo highway in Colombia (Stage 1). The typology of the bridge consists of a simply supported span, composed of a steel beam deck and a reinforced concrete slab. It also has two reinforced concrete abutments with shallow foundations (Figure 11).

**Figure 11.** Chichaca Bridge typology.

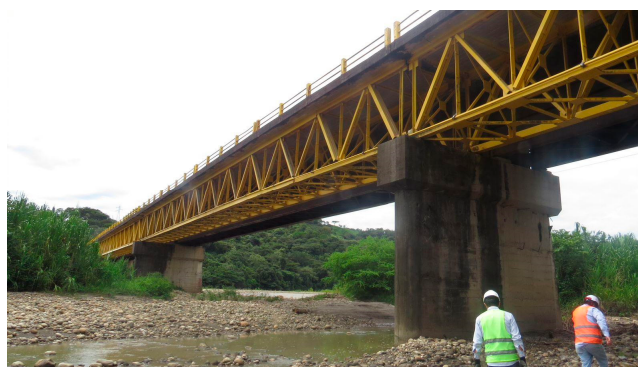
The findings led the Instituto Nacional de Vías to make the necessary temporary or permanent interventions to prevent the bridge from collapsing. As a result, traffic on the Ramón Nonato Pérez Bridge was restricted to one lane, as shown in Figure 15, where the main finding was cracking in the welded joints of the truss bridge. This bridge has a combined typology because one lane is steel reinforced, and the other is a mixed steel–concrete section.

**Figure 15.** Ramon Nonato Pérez Bridge.
