# A New Module for the Evaluation of Bridges Based on Visual Inspection through a Digital Application Linked to an Up-to-Date Database of Damage Catalog for Colombia

**Abstract:** Road structures undergo a series of chemical and physical processes once they are put into service. This phenomenon results from the action of the load and the influence of the environment, which causes their progressive deterioration. In order to mitigate the risk of progressive deterioration and guarantee their stability and durability, various maintenance tasks are required, including visual inspections. The Intelligent Bridge Management System of Colombia (SIGP) includes visual inspection as one of its modules. The system has been designed based on state-of-the-art criteria and national experience with relevant damages and bridge collapses. This paper presents the visual inspection methodology, which includes several stages such as a classification scale, condition index, evaluation areas, damage catalog, and evaluation criteria. In addition, a digital application has been developed to facilitate real-time data collection during field inspections using mobile devices, which can be uploaded directly t

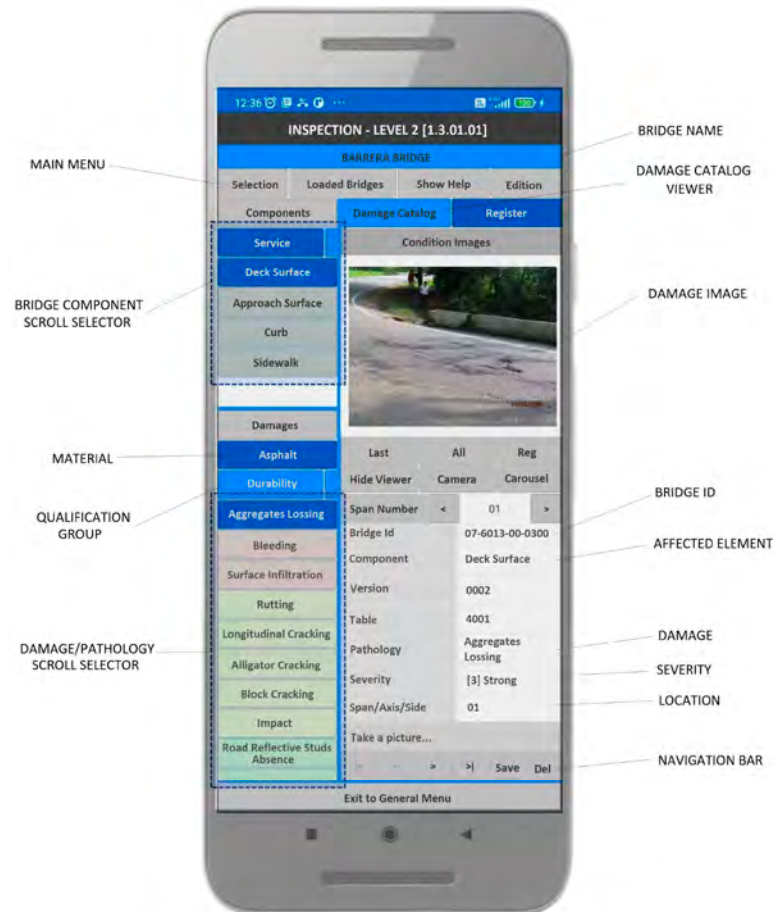
A mobile application (shown in Figure 4) has been implemented to digitally capture data associated with visual inspection tasks. This increases the data acquisition on field. It is important to document any damage and record its extent and severity using built-in rubrics. Relevant inspection information should be imported to identify components associated with the inventory. The status of routine and preventive maintenance should also be recorded. Finally, the collected data should be exported to a central geodatabase in the cloud. This development is part of a line of research around the world where technological applications are being implemented to support visual inspection and damage detection on bridges [30,33–38]. The time during which this application should be used in the field depends on the index of each bridge, as explained in Table 3. This time varies from an immediate visit to the bridge if it has an index of “Susceptible to partial or total failure” to 5 years for an index of “Satisfactory”.

Figure 4. App for collecting information in fieldwork.

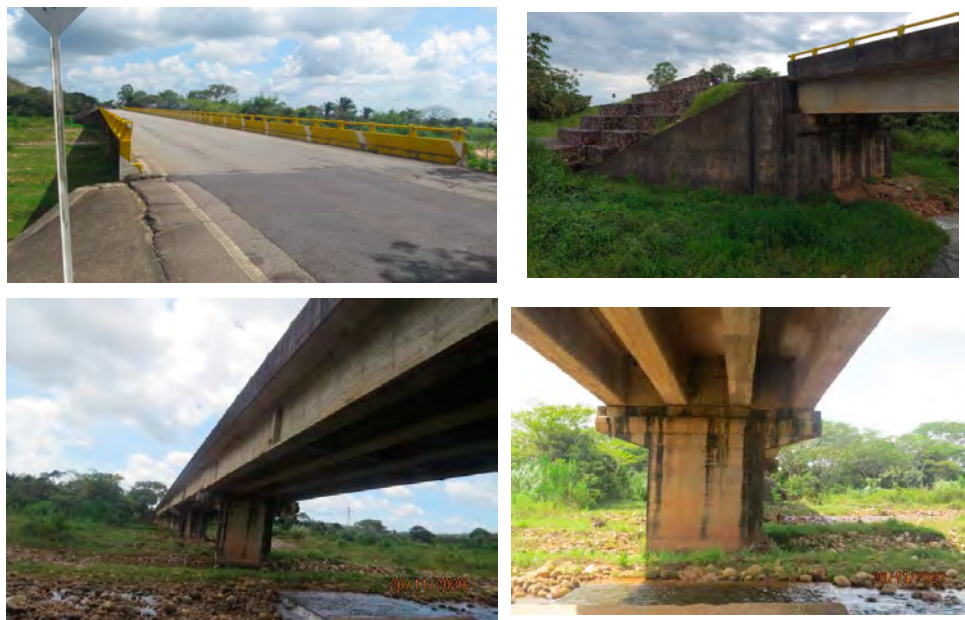
application of the methodology. The Guacharí Bridge is located on the Paz de Ariporo highway in Yopal, Casanare, Colombia. The bridge was built in the 1970s, and its typology includes five simply supported spans, consisting of a deck and slab in prestressed concrete. It has four reinforced concrete piers of the wall type with header beams and two abutments, also of reinforced concrete, with shallow foundations (see Figure 9).

**Figure 9.** Guachiría Bridge typology.

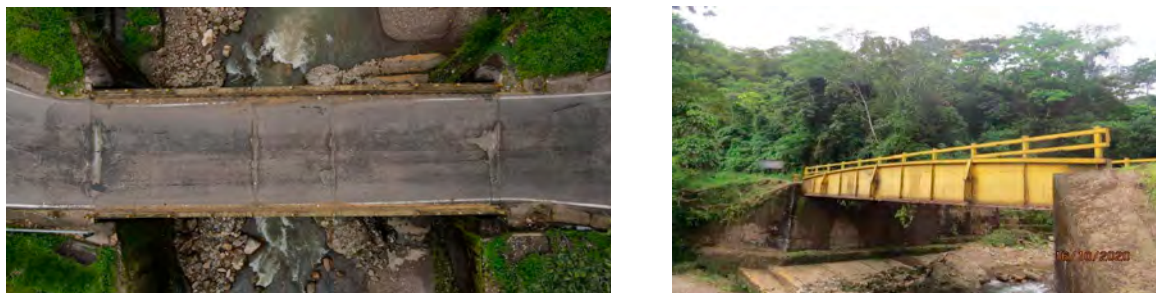
The Chichaca Bridge, which is the second bridge, also belongs to the Casanare area and is located on the Yopal-Paz de Ariporo highway in Colombia (Stage 1). The typology of the bridge consists of a simply supported span, composed of a steel beam deck and a reinforced concrete slab. It also has two reinforced concrete abutments with shallow foundations (Figure 11).

**Figure 11.** Chichaca Bridge typology.

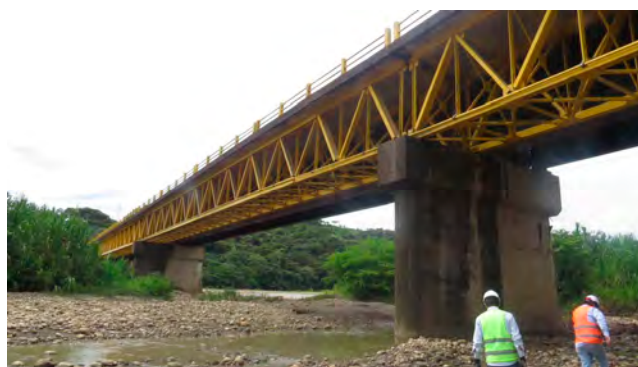
The findings led the Instituto Nacional de Vías to make the necessary temporary or permanent interventions to prevent the bridge from collapsing. As a result, traffic on the Ramón Nonato Pérez Bridge was restricted to one lane, as shown in Figure 15, where the main finding was cracking in the welded joints of the truss bridge. This bridge has a combined typology because one lane is steel reinforced, and the other is a mixed steel–concrete section.

**Figure 15.** Ramon Nonato Pérez Bridge.
